1980

**EDGEMONT AND EAST DURHAM
EARLY TEXTILE MILL VILLAGES**

DURHAM, N. C.

Report produced by the Historic Preservation Technology Class
of 1978-1979
Durham Technical Institute

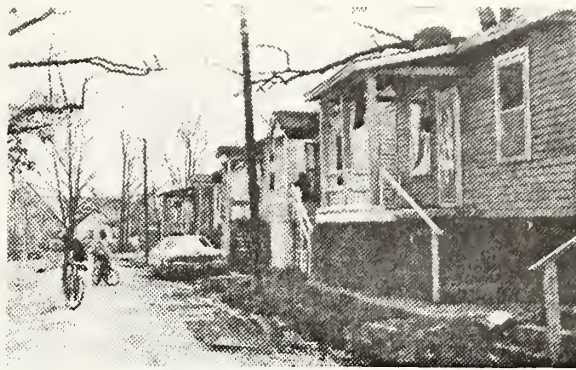
Fig. 20 Streetscape, mill housing on South Holman Place.

In 1922 the mill was reorganized as the Morven Cotton Mill, one of a chain of mills operated by northern capital for the manufacture of mixed cotton and silk goods.¹⁹ The block of 6 small rectangular houses, set close together, on the south side of South Holman Place, a dead end street directly behind the mill, were probably built at this time for employees. These are very small 1-story single family houses. The form of these dwellings is unique in the inventory area, and may represent mill housing model imported from the North (fig. 20).

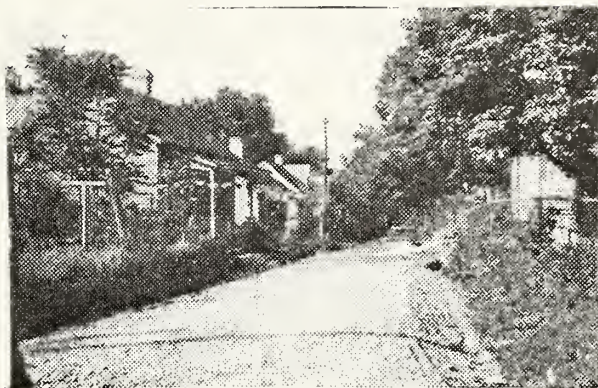
Fig. 23 Unpaved Laurel Street

Two-thirds of Edgemont's original housing is gone due to demolition of substandard buildings and new commercial construction. Frequent littered vacant lots interrupt the streetscape and many streets are still unpaved (fig. 23). Yet a sense of neighborhood is strong in Edgemont. The area retains the strongly rural feeling which first made it attractive to the farm folk attracted to Durham by the new factories. There is space to grow corn, raise chickens, kennel dogs, and set up a full basketball court. Nearly all the houses are occupied by families or elderly persons, and children and gardens are everywhere (fig. 24). Hopscotch is chalked on the asphalt, and there is always street and porch visiting in progress in the warm months. An informal network of mutual watchfulness and assistance operates among the residents. In winters, wood is chopped and carried by those who can for those who can't. In summers, help is given and company kept while cars are washed and repaired and garden vegetables put in. Evenings are decidedly social. The Reverend John Moore, whose Faith and Hope Mission Holiness Church has been a center for the community, summed up the feelings of many of the residents: "They love this neighborhood... and its conveniences. It's close to their work, to the bus lines, to the A & P and to the fish market. They don't want to leave it."²⁴

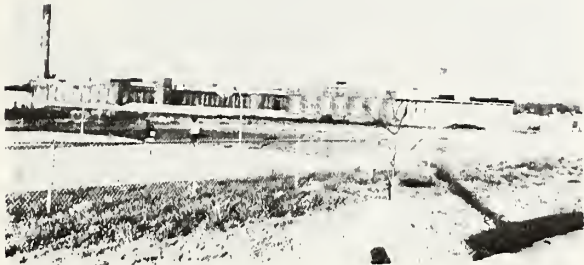
1. Golden Belt Manufacturing Company.
807 E. Main Street bounded by E. Main, Belt, Taylor and Elizabeth Streets. 1902. This plant, still in operation, is divided into 2 mills, a cloth mill and a bag mill both brick structures with 2 towers decorated with heavy corbeled brick work. Company organized in 1899 but is actually a decendant of the Blackwell Bull Durham Tobacco Company which maintained a small outfit to manufacture cloth pouches for smoking tobacco. Now owned by American Tobacco Company.

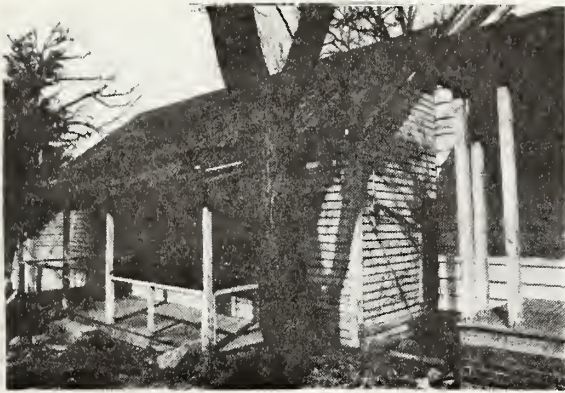
2. 112,114,116 Lyon; 911,913 Dale Alley. Pre-1913.
Group of five gabled, two-bay frame duplex mill houses. Each has 2 front doors, central chimney, front shed porch, shed rear wings. Each living unit apparently consisted of 2 or 3 rooms and a bath. Probably built by the Durham Hosiery Mill. Good condition.

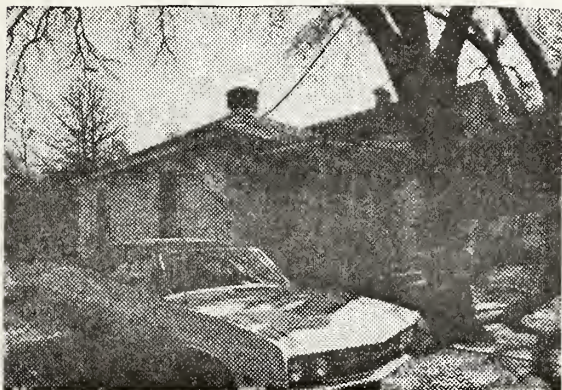
3. 903 Dale. 1913-1937.
Low hip-roofed 3-bay single family mill house, with German siding, central chimney. Hip-roofed front porch with turned posts and small sawn brackets. Fair condition. Unique configuration for this area of Edgemont.

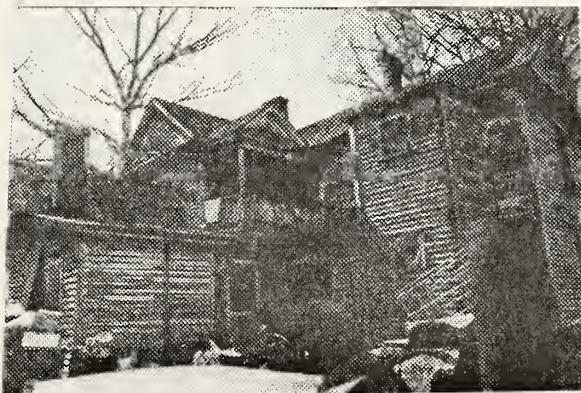
4. 909 Dale Alley
Large 2-story Victorian house, with several rear additions which form an interesting roofscape. Large front porch with turned posts and decorative sawnwork. Most notable house in neighborhood for its size and uniqueness. Fair but deteriorating condition.

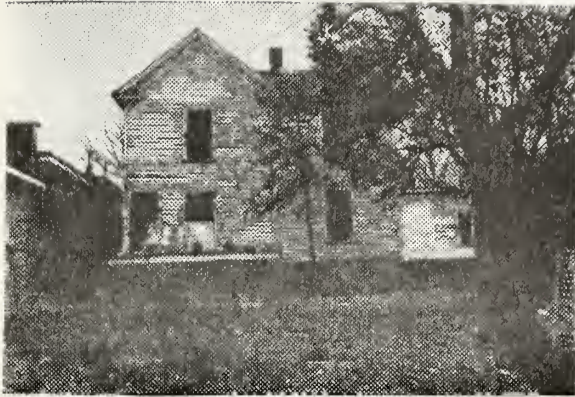
5. 101 S. Elm. Pre-1913.
2-story cross-gable house with interior chimney, 2/2 sash windows, missing porch but pilasters remain. Nice original paneled double doors are now blocked by neighboring buildings and a new "front" added on Elm St. side. This house is fancy, with Victorian flavor typical of Main St. but not of general area.

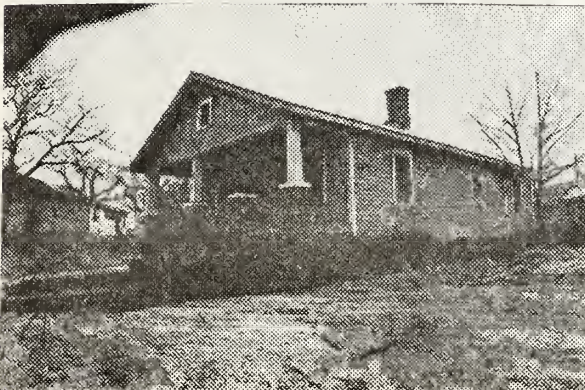
8. 121 Lyon St. 1913-1937.
Single family bungalow. Center chimney, 4 narrow vertical lights over 1 large light sash, paneled front door. Gable end faces street and forms pediment over engaged front porch, with tapering box columns on brick piers for porch posts. Good to fair condition.

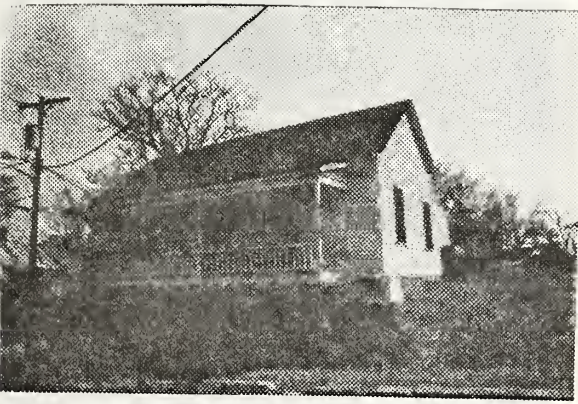
11. 115 Lyon. Pre-1913

Simple, traditional 1-story gabled single family house with center door, 6/6 sash, 2 interior chimneys, full brick foundation, weatherboard siding, nice high porch extending the full length of the facade, with original turned posts, railing probably replacement. Probably a mill house, but slightly larger than typical.

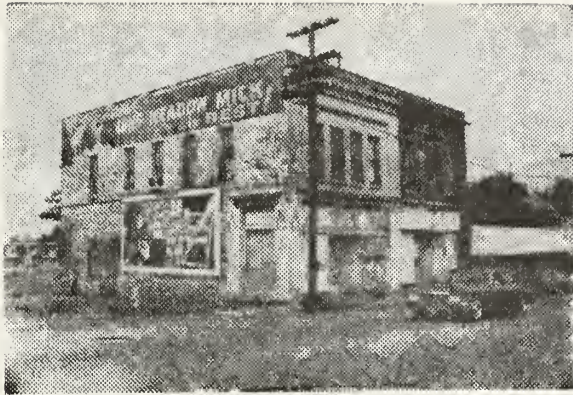
12. 903,905 E. Main St. 1913-1937
2-story brick flat roof business building 6 bays wide and 5 bays deep with handsome Renaissance Revival style metal cornice. Ground floor has 2 store fronts each with typical plate glass windows and replacement recessed center door. This building has modest ornamental brick work and though larger than its neighbors is still typical. Although no longer used it appears still serviceable.

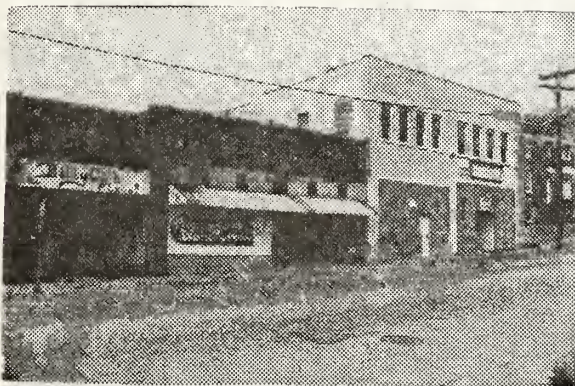
18. 933 E. Main St. Circa 1920
 A 2-story masonry store building with an apartment on the second floor lighted by 9/9 sash windows. The ground floor features a door to the apartment in the south-west corner and a typical plate glass store front with a recessed center door under an aluminum awning.

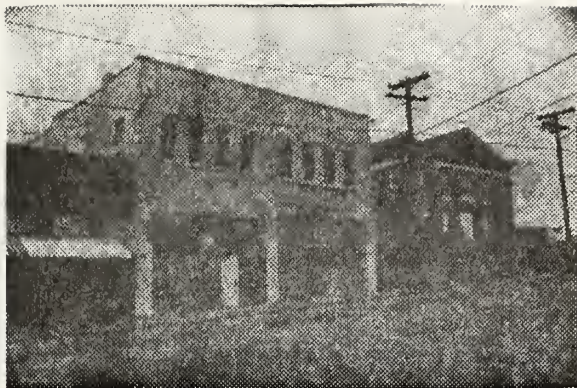
20. 951,953 E. Main St. Circa 1920
2-story brick commercial building 8 bays wide, with flat roof. Originally had 2 store fronts on the ground floor which are now covered up with replacement materials. 2nd story presents a row of four 6/1 windows over each store front. Has decorative cement squares and diamonds between 1st and 2nd story and in parapet. There are pilasters on each corner and in the center.

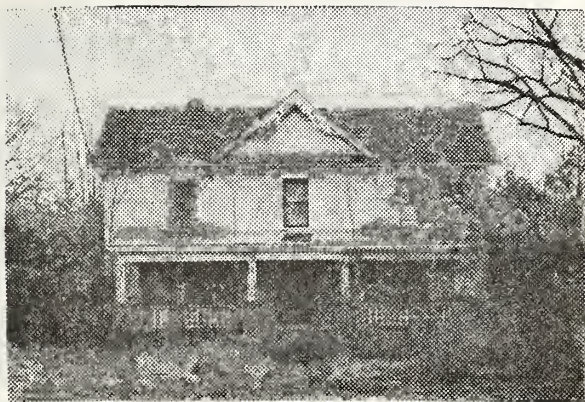
21. 1006 E. Main. Pre-1913.
2-story frame 4 bay L-shaped house with an interesting front 3 bay gable featuring scalloped siding and ornamental bargeboard sawnwork. Front eaves are accented by curvilinear sawnboards. The windows are 4/4, the front porch has a hip roof with turned posts, and the front yard is enclosed by a notable cast-iron fence. Vandalized and in fair to poor condition.

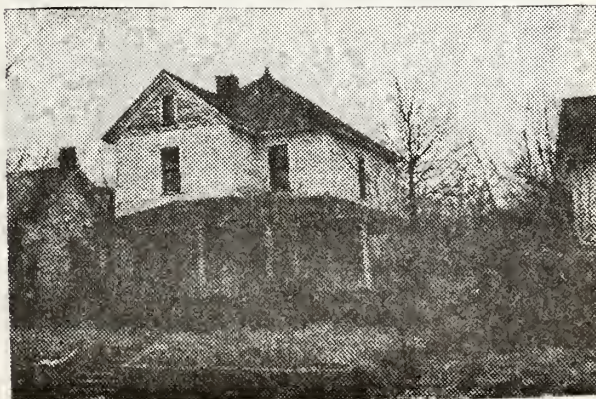
22. 1008 E. Main. Pre-1913.
Familiar 3 bay wide, 2-story I-house with elaborate Queen Anne style front gable. 1/1 and 2/2 sash windows, shed porch with replacement posts. Fair conditon.

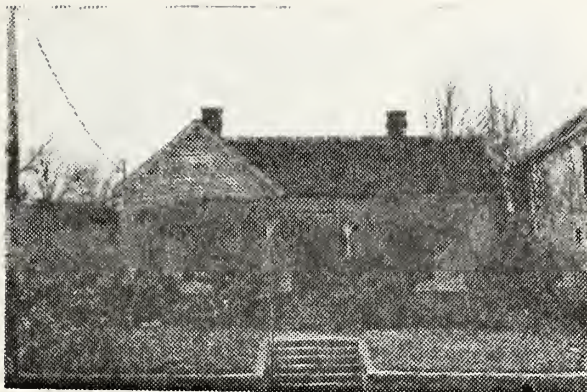
24. 1012 E. Main. Pre-1913.
1-story L-shaped house with left front gable, sawnwork brackets on porch, turned posts, corner block in door trim, and decorative interior mantels with cast-iron fireplace coverings. Community clinic until January 1979 when vandalism forced it to move. Good condition.

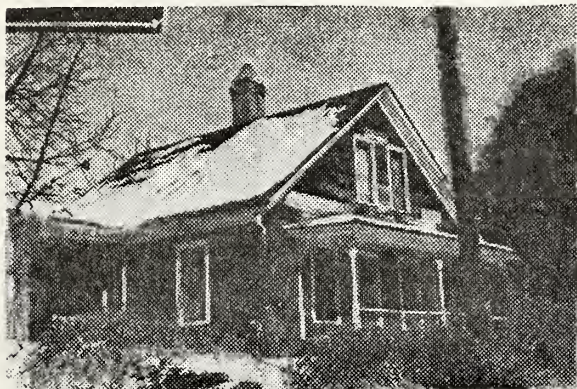
25. 1016 E. Main. 1885.
Interesting 1 1/2 story miscellaneous Victorian style gabled house, double front entry with hall ascending into upper sections, tall narrow Federal-like dormers, boarded-up windows, brick asphalt veneer siding, curvilinear bracket on front porch. Abandoned, poor condition.

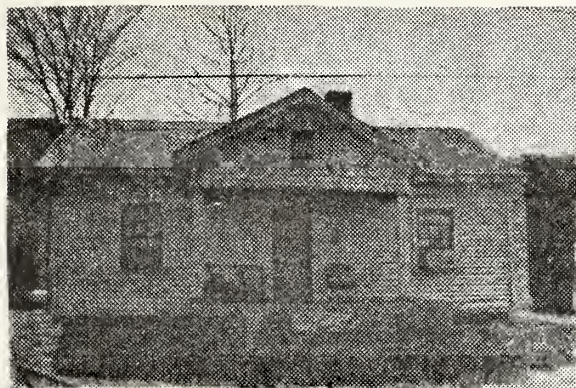
26. 908 Morning Glory. 1913-1937
Rectangular 1-story frame single family house, 3 bays wide, with a 1 bay gabled front porch with squared wood posts. German siding, 6/6 sash windows and a 4-light over 3 panel door.

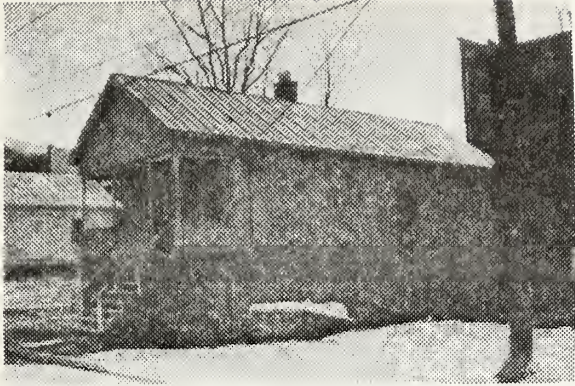
28. 914 Morning Glory. 1913-1937
 1-story small plain shotgun house set on tall brick piers, now infilled. Interior chimney, engaged front porch with turned posts, tin roof. Nice Queene Anne screen door is intact. Fair condition. Only shotgun house in this section of Edgemont.

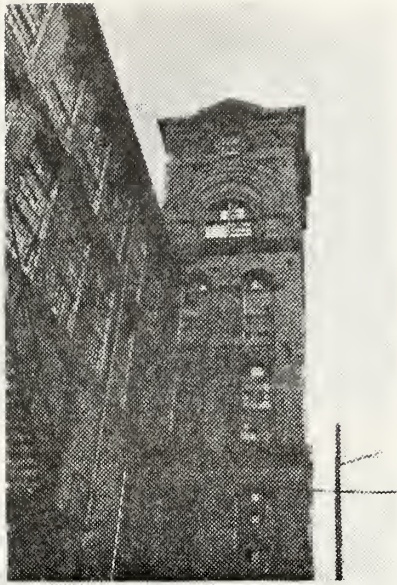
34. Durham Hosiery Mill Angier Avenue. 1901. Oldest building is a 4-story brick structure with bracketted eaves and segmental arched windows. Most notable feature is the 6-bay tower divided into 3 parts by 2 heavy corbelled brick string courses. Company founded in 1894 but did not prosper until it came under the direction of Julian S. Carr. Carr's son, Julian Jr., took active control of the company which at one time included 15 factories in North Carolina.

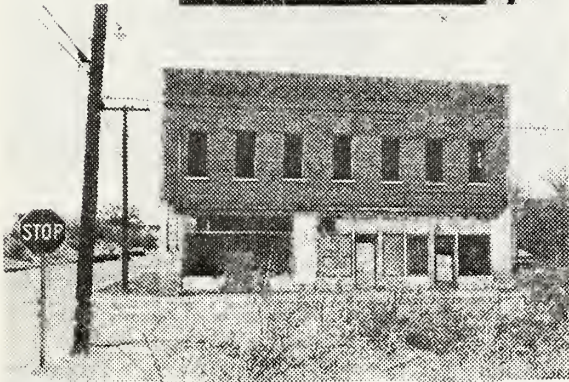
35. 901,903 Angier Avenue. Pre-1913. Two story seven bay retail building. One of two commercial buildings on this block diagonally across the street from the Durham Hosiery Mill. Decorated only with corbelled cornice. Structurally sound though interior and store fronts are much altered and deteriorated.

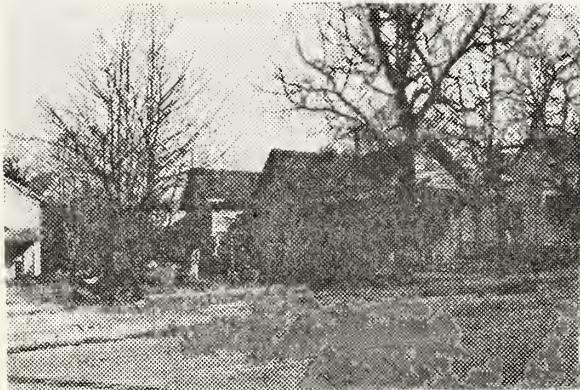
36. 907,908 Angier Avenue. Pre-1913 1-story "L" shaped frame mill houses; two bays with recessed front doors in left bay, rear additions are set at right angles to the main ridge line; attached wrap around porches with turned posts and sawn brackets. 908 Angier is modified by an extension of the left bay and a replacement picture window.

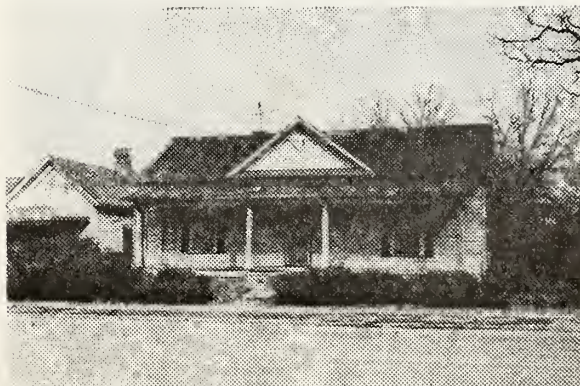
37. 911 Angier Avenue. Pre-1913 1-story "triple A" frame, three bay, gable end roof with returns. 2/2 sash windows, rear ell, attached shed roofed porch supported by tapering posts.

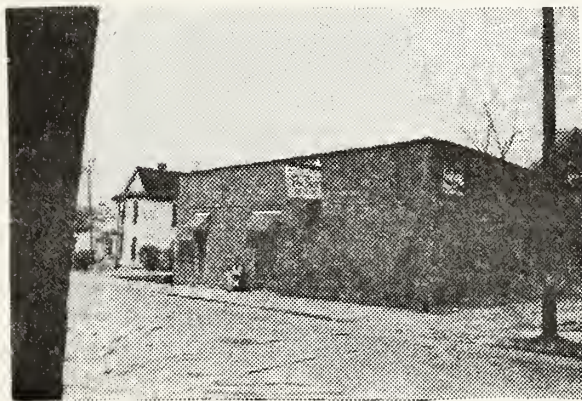
39. 916 Angier. Pre-1913
Small two-story, two bay, "L" shaped mill house with a hip roofed porch across the front below a pedimented gable over the left bay, 4/4 windows. One of only two two-story houses in the area. In fair condition.

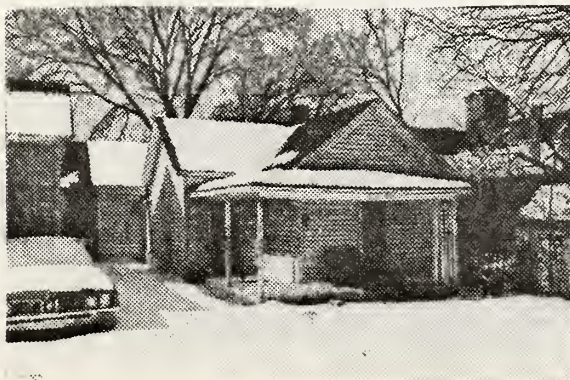
41. 906,908 Dale. Pre-1913
1-story "F" shaped cross gabled frame mill houses with interior chimneys, rear additions. Attached hip roofed, wrap around porches. Fair condition.

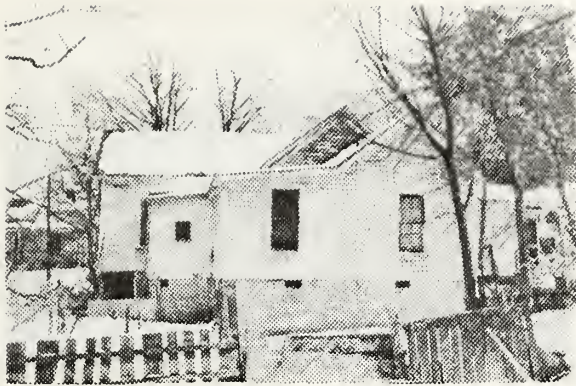
42. 912 Dale. Pre-1913.
1-story "L" shaped cross gable frame mill house with front cross gable and extensive gable and shed roofed rear additions. Spindle frieze on the front wrap around hip porch with turned posts. Abandoned, and suffering accelerated deterioration due to water damage.

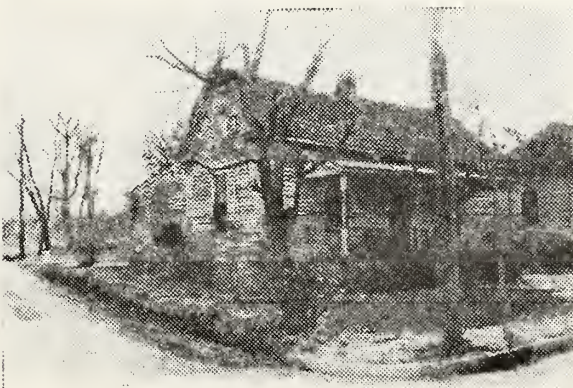
45. 209 East Elm. Pre-1913
One-story frame mill houses with addition, probably built as mill housing for the Durham Hosiery Mill. Front shed porch supported by turned posts, lighted by large 6/6 sash windows. End gable roof with wide returns. Common example of plain mill housing. Deteriorated condition.

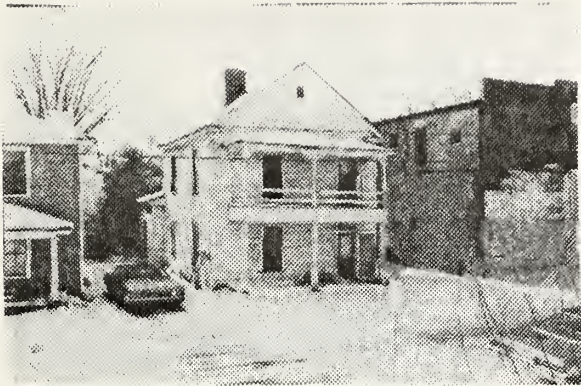
50. 121 South Elm. Pre-1913.
Two-story frame mill housing duplex set gable end to street. Front two story hipped porch with decorative sawnwork brackets and turned posts, handsome Queen Anne front door, eave returns, German siding and interior rondel corner blocks. Abandoned, but a good candidate for rehabilitation.

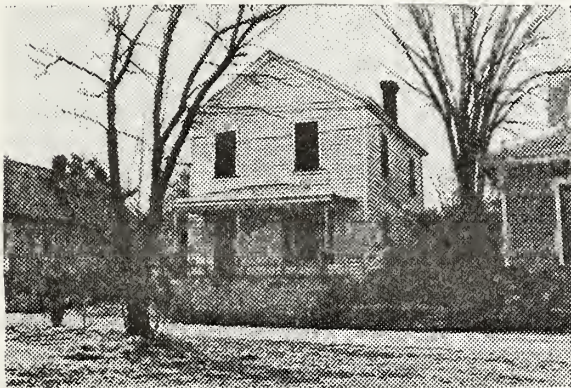
51. 904 Halifax. 1913-1937.
A compact two-story front gable mill house with hip roofed front porch supported by turned posts, rear shed wing. The simple facade looks quite stately among its single story neighbors. Good condition.

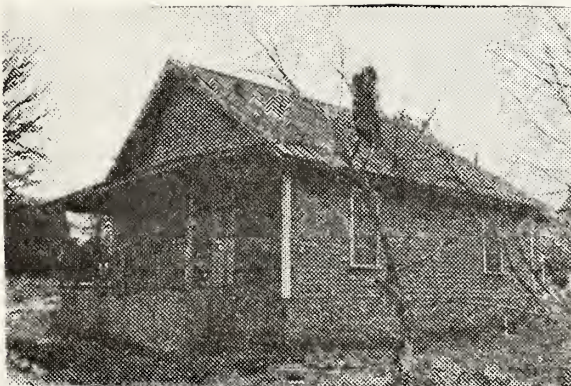
53. 906 Halifax. 1913-1937
One-story, three bay frame mill house duplex; interior chimney; front gable roof with bracketed eaves. Front shed porch with turned posts. Good condition.

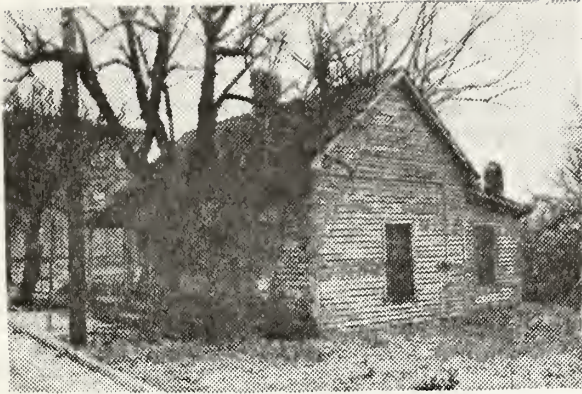
58. 403 Walker. Pre-1913
A four bay, single story, end gable duplex mill house with shed roofed rear wing, located very near the Durham Hosiery Mill. Shed roofed front porch, central interior chimney, and six over six windows complete the details of this mill house, now in fair condition among similar neighbors.

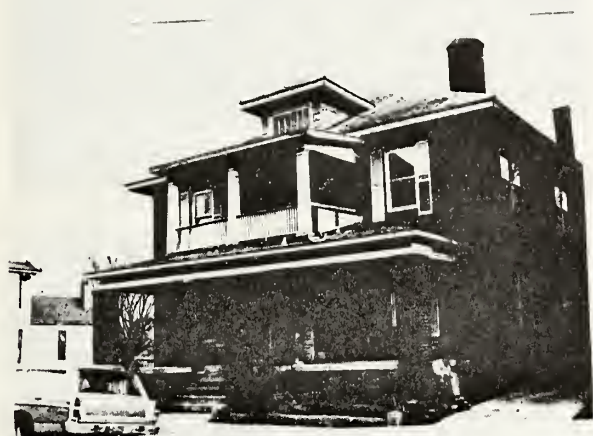
68. 215 Hood Street. 1913-1937

Two-story three bay brick four apartment house which retains its original use. Pyramid asphalt shingled roof with metal ridge coping has front shed dormer, 2 interior chimneys. 1/1 sash present in single front windows with shutters and paired side windows. Four square brick posts support 1-story hip porch roof, which has been altered for the addition of a small 2nd floor porch having square wood balusters and posts surmounted by a shed roof.

With 217 forms a pair of apartments similar in size, placement on lot, and ambience but of different styles. In very good condition, these apartments and the two remaining houses on Hood make an attractive grouping pulled together by the short cast concrete "curbs" in front of each of the properties.

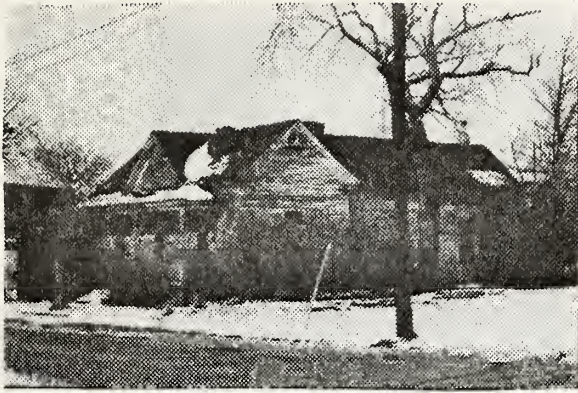
One of a pair of adjacent back apartment houses similar in age and style yet different stylistically.

In good condition, makes an attractive grouping with 215 and the other remaining residences on this side of Hood Street.

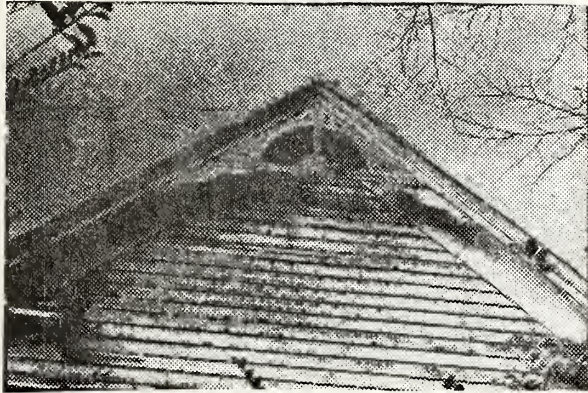
70. 607 Ranseur Street. Pre-1907 (Demolished May 1979)

One-story single family Victorian frame house with turned sawnwork in bargeboards of 3 gables and wrap around porch, 4/4 sash, glass and paneled front door with transom, 2 interior chimneys. Double gable wings to rear have enclosed breezeway between. Interior has turned and carved mantels, window and door corner blocks, and lovely sawnwork cresting over interior louvered partition separating front from rear hall.

Deteriorated condition but with virtually all decorative features intact. Only house remaining in this block, and very evocative of local frame interpretation of Victorian and Southern architecture, down to lattice screen across rear shed porch.

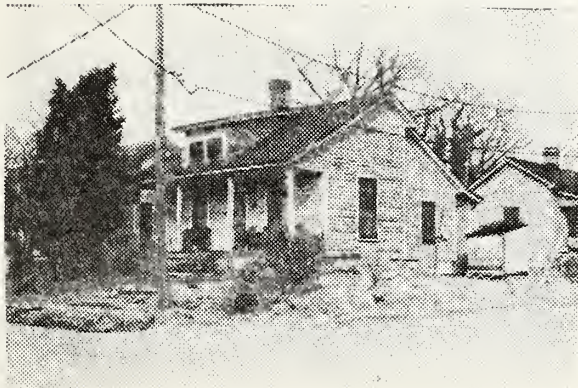
71. 705,707 Ramseur Street. 1913-1937

Pair of 1-story, 3 bay "broken" pile frame mill houses, originally duplexes, now single family, with single interior chimneys, 2/2 sash, quarter round corner boards, narrow double panel and glass front doors, false shed dormers on roofs of engaged front porches with some replacement posts. Continuous cast concrete retaining walls, steps to sidewalk and property corner posts further pull the two together.

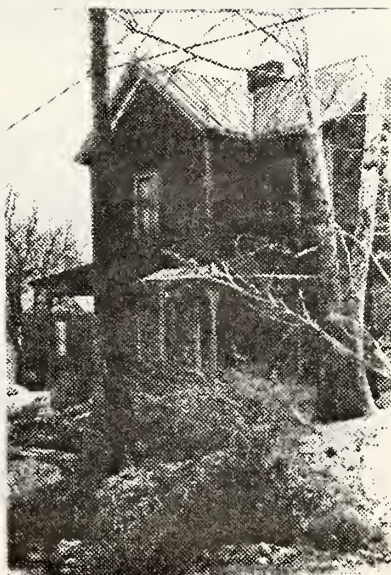
73. 817 Ramseur Street. Pre-1907
 Single family one story Victorian frame house with exterior end chimneys, 2/2 sash, front gable louvered ventilator with sawn star, front shed porch with original slender columns, French front door with segmentally arched transom. The facade windows have been remodeled but side windows are segmentally arched with Italianate gable hood molds. In good condition, but encroached upon on all sides. Only remaining residence in this block of Ramseur Street.

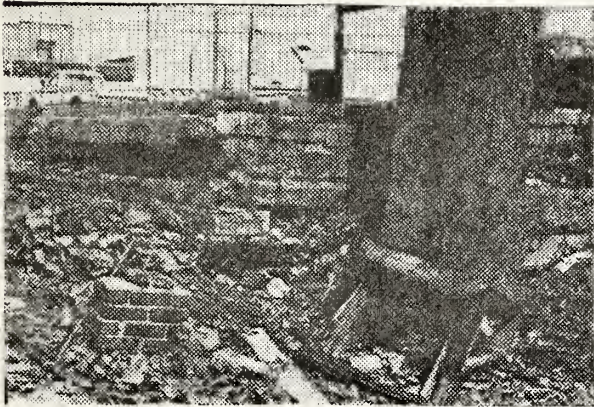
76. 114½ Walker Street. Pre-1913
Cut stone stable or garage foundation, about 2' at highest point, probably originally built for large 114 Walker Street house. Sanborn Map indicates that by 1937 another structure occupied the site, identified as 205½ Hood Street, probably using the same foundation. A contemporary carport stands on the now unused lot.

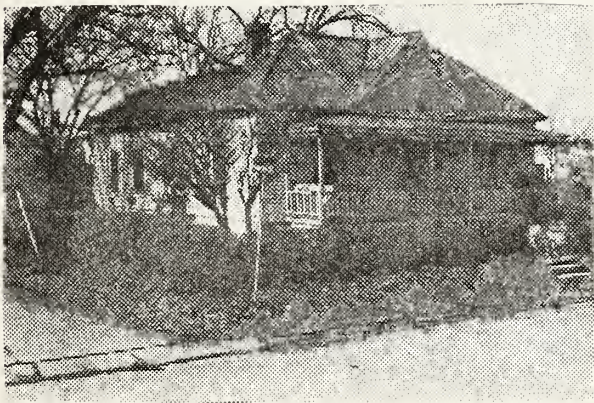
77. 206 Walker Street. Pre-1907
Frame single family 1-story, 3 bay house with unusual combination hip and front gable roof, interior rear chimneys, 6/6 sash, German siding, quarter round corner boards, and Queen Anne front door. Front hip roof porch, probably original, supported by square chamfered posts; beaded rail and square balusters.

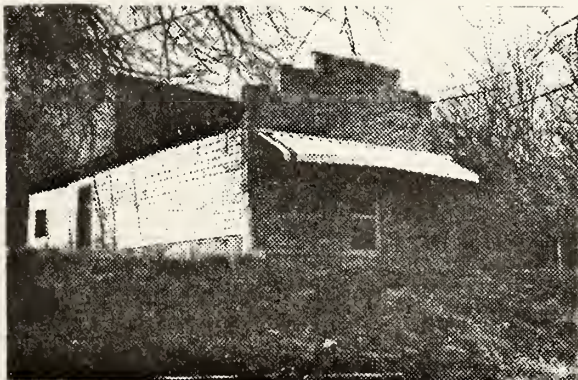
This sturdy unpretentious house, in good condition, is remarkably unchanged since its earliest mapped documentation, the 1907 Sanborn Insurance map.

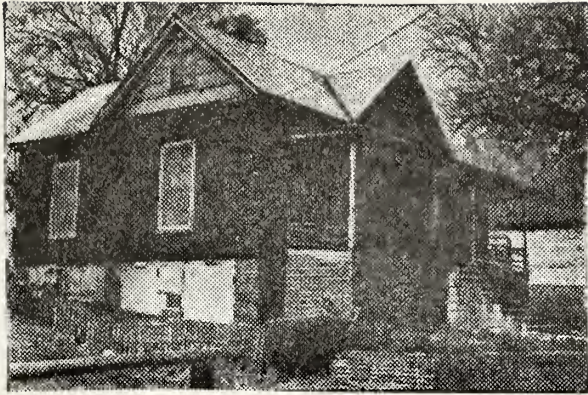
79. 418 Walker Street. Pre-1913
One-story, 5 bay frame house, originally single family but now a duplex, with double gables to rear, each having an exterior chimney. Symmetrical facade has a window and a panel and glass door on each side of a newer small center window, all surmounted by a hip roof porch with original turned posts, sawnwork brackets and drip course.

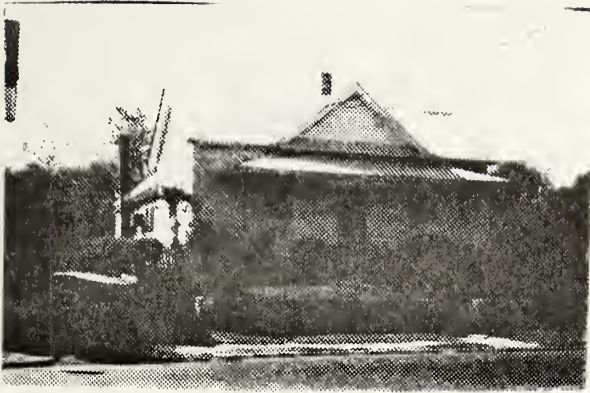
80. 208 South Alston Avenue. Pre-1913
Usual residence, 1-story "triple A" with central chimney, German siding and aluminum ridging on its north wall. Windows are 1 over 1 replacement. The front porch has replacement ironwork posts and a concrete floor.

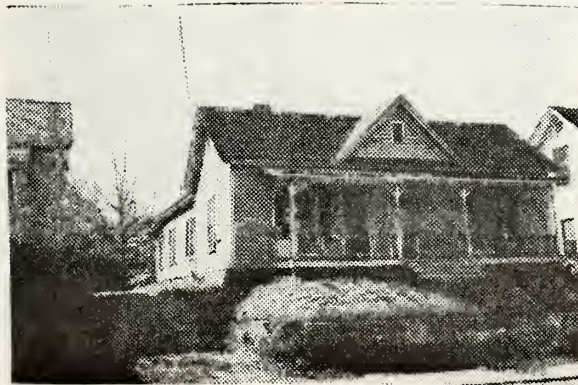
82. 210 Alston Avenue. Pre-1913
A good example of a central hall residence. Facade with a central gable flanked by dormers with 2 over 2 sash windows and an interior chimney. Unusual double leaf front door. Porch has turned posts, brackets, and drop and sawtooth courses. It has a double leaf front door with vertical lights over two panels. It has the usual German siding and 4/4 sash windows.

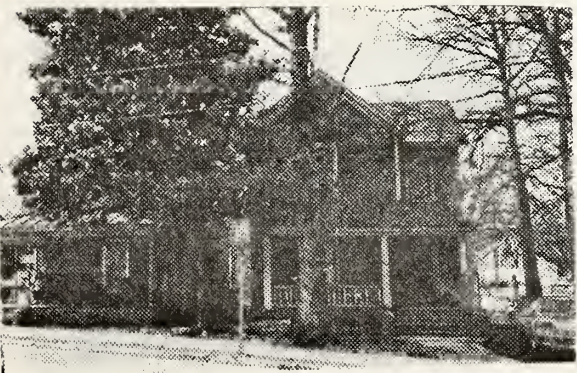
86. 220 Alston Avenue. Pre-1913
"L" shaped mill house with entrance in the gable end on Peabody Street. 2/2 sash, original doors, interior chimney, very nice wrap around front porch with hip roof, original turned posts and railing. Very good shape.

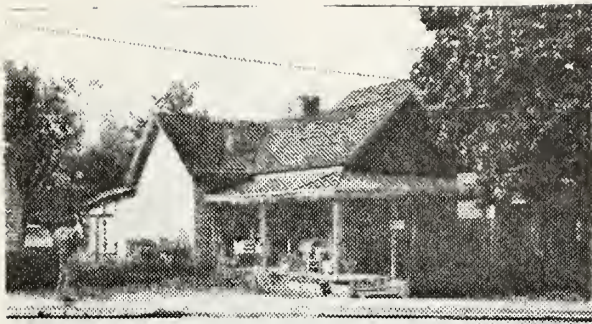
87. 1002 Angier Avenue. Pre-1913
Compact 2 story side hall, single family houses with a one-story porch with original squared and capped porch columns and a plain railing. Original 2 over 2 sash and original door. May not have been mill house. Good shape, worth saving.

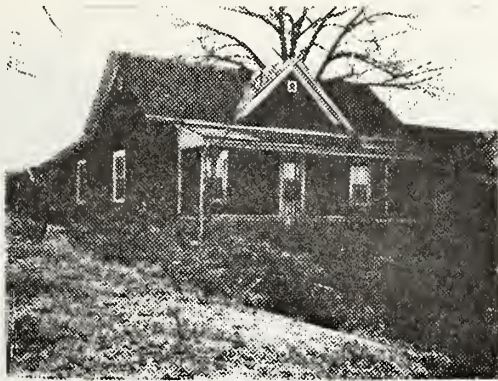
88. 1004 Angier Avenue. Pre-1913
One-story single family, "L" shaped house with German siding, wrap-around porch with 2 original turned posts. 4/4 sash. Replacement porch posts and siding are result of cars hitting house, as it sits on sharp curve of the road.

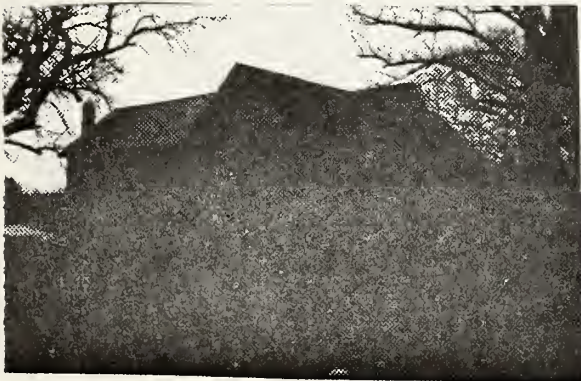
89. 1006, 1008, 1010, 1012 Angier Avenue. Pre-1913
A group of 4 1-story frame, single family houses each with 2 interior chimneys and 4/4 sash, center front door and rear sheds. Shed roof front porches with turned or chamfered posts. Probably built for Durham Hosiery mill. Most of these houses are in fair condition and may be worth saving.

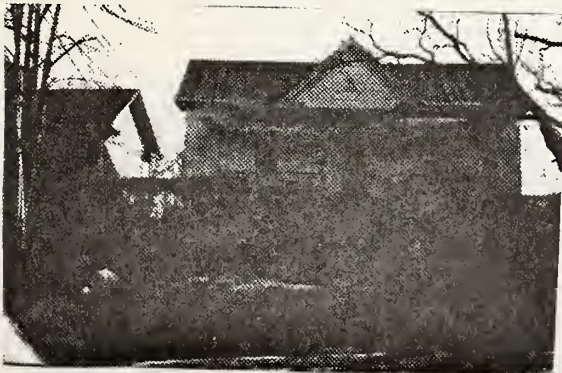
90. 1014 Angier Avenue. Pre-1913
Typical cross gable 1-story single family house, interior chimney, 2 exterior straight stack chimneys on rear. Front shed porch with 2 original turned posts with pierced curvilinear brackets, original vertical light front door and 6/6 sash.

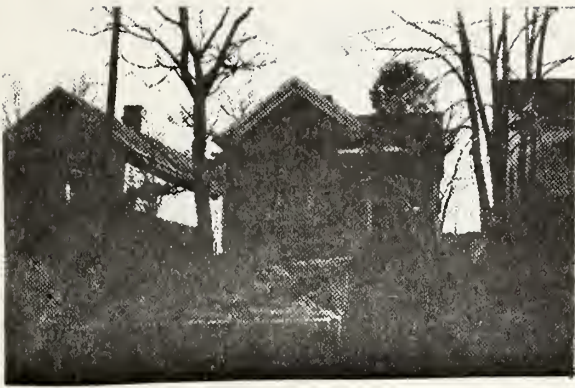
91. 1018 Angier Avenue. Pre-1913
1-story "triple A" single family house with rear "ell" and addition. Center interior chimney, 4/4 sash, replacement front door and replacement asbestos siding. Hipped roof front porch with some original turned posts with scalloped brackets. Fair shape.

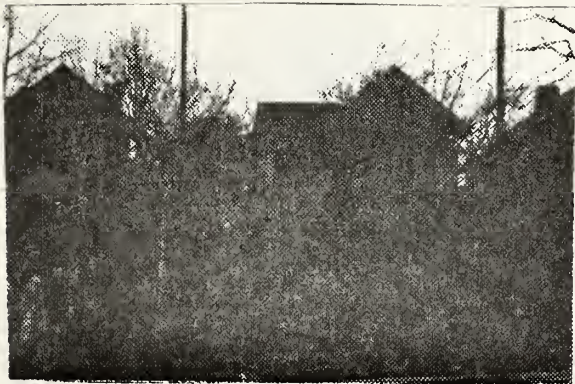
92. 1020 Angier Avenue. Pre-1913
"L" plan one-story single family house with rear addition, wrap-around porch, with squared posts and plain railing. Well kept up and worth saving.

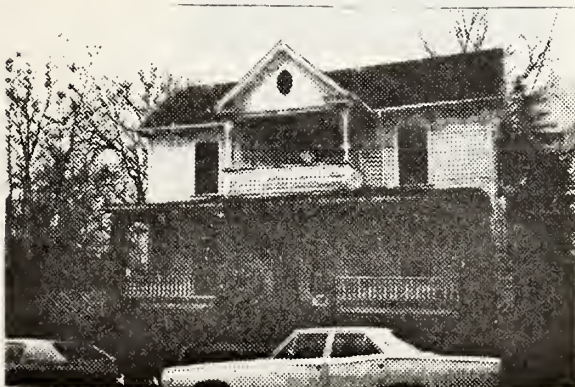
94. 1024 Angier Avenue. Pre-1913
An interesting example of a "F" plan with a side wing, wrap-around porch with turned posts and curvilinear brackets. Poor shape.

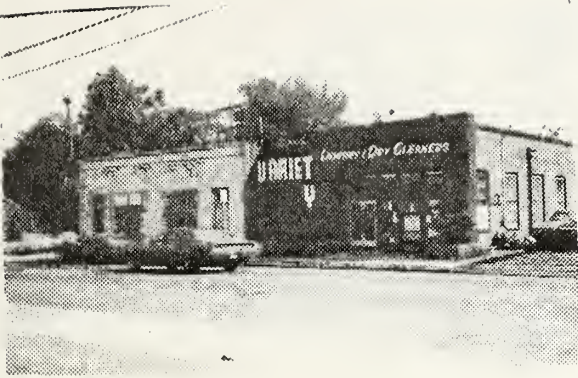
99. 1208 Angier Avenue (Riteway Cleaners).
1913-1937
One-story load bearing brick commercial building. Main facade in 3rd or 4th remodeling. Flat roof. Good shape and a thriving business.

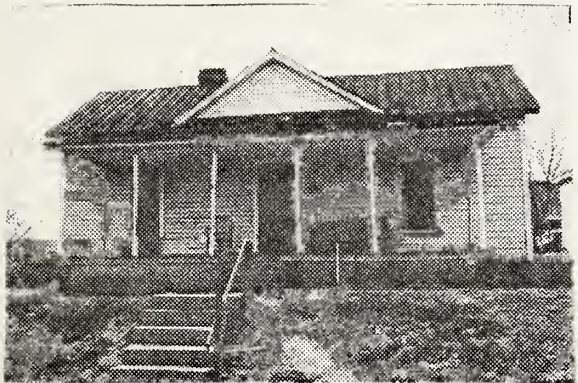
101. 1010,1012,1014 Calvert Street. 1913-1937
Group of three 1-story houses built as duplexes. All have the same form but different roofs and porches. The windows are all similar to each other and may have been salvaged from an older house. The sashes include 4 vertical over 1, 6/6, and 4/4. All have interior chimneys and German siding. Two have front engaged porches, one has a front hip porch partially closed in to provide indoor plumbing.

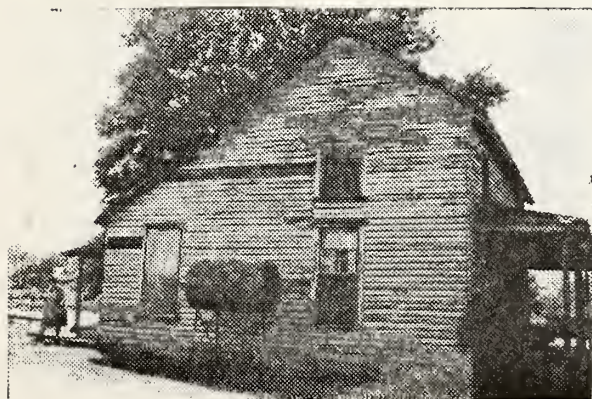
103. 1210 South Holman. 1913-1937
Two-story "cat slide" or "salt box," type duplex, now single family. 6/6 and 4/4 sash and loft casements, center chimney, both original and replacement doors. Hip roof front porch with replacement posts. House needs work but basically sound. One of four identical houses in this block on 1937 map which were probably built for the Morven Cotton Mill about 1922.

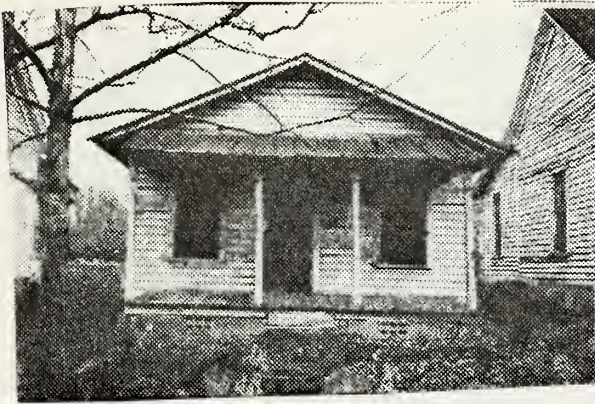
105. 209½ Laurel Street. 1913-1937
This house is a "shotgun" type, probably mill housing with front end gable, center chimney, shed roof front porch, 4/4 sash and a front door with two vertical lights that is probably original. This is the only one of its type on street. Not in good shape and may be past saving.

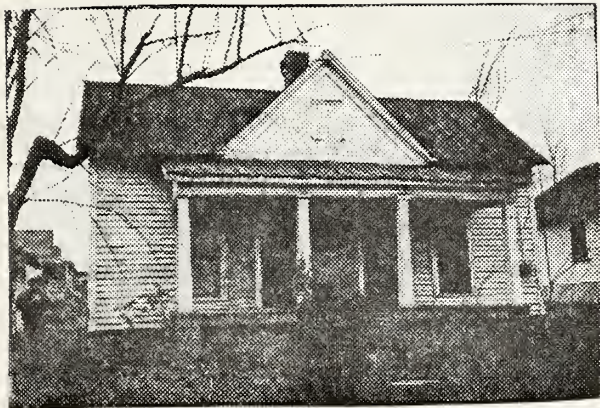
106. 211 Laurel Street. Pre-1913
This mill house duplex has a "triple A" roof, a center chimney, rear "ell" addition, 4/4 sash, raised paneled front doors, a shed roof front porch with square box-type posts that are probably replacements. The Queen Anne shingle treatment of the gable sets this house apart from the rest of the "triple A" houses on Laurel Street. House is presently vacant and may be unsavable.

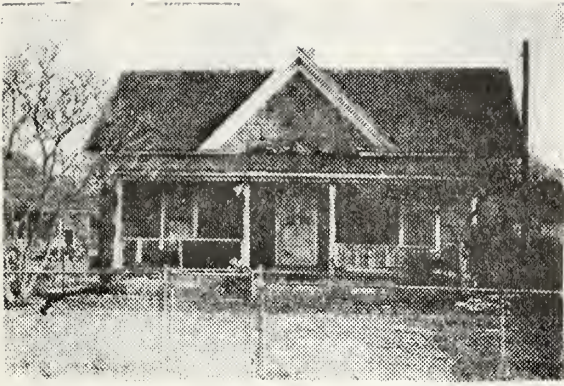
This one-story, 2 bay former duplex is definitely a mill house. Centrally located chimney, several original 2/4 sash windows. The walls have the typical German siding. The porch posts have been replaced with plain squared posts, typical of replacement parts in the neighborhood.

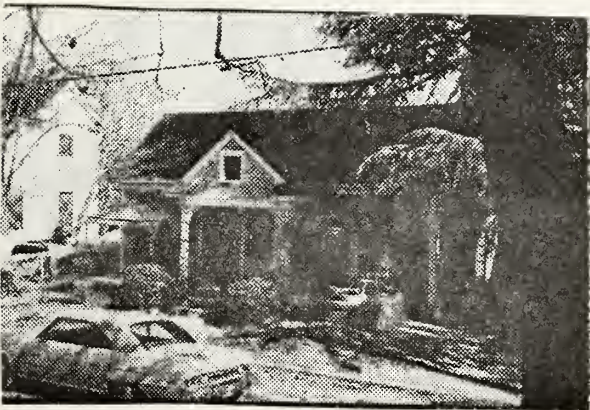
114. 205 Stokes Street. Pre-1913
One-story late Victorian gabled house, sash with simple Tudor style glazing and similar front door. Probably not a mill house. This house has been modified at least twice. Additions include an exterior curved single shoulder chimney, a front single bay gabled stoop with iron posts and asbestos siding. In good shape and is worth saving if threatened.

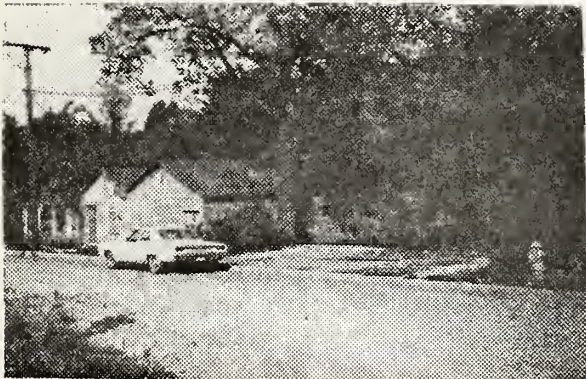
118. L and O Hosiery Company.
219 Stokes Street. Pre-1937
 This single story rectangular frame mill is covered by a pair of gable roofs, set end to street. It has several chimney flues for wood or oil heaters and a rear addition. The 6/6 sash windows and doors are mostly boarded up. Deteriorated generally, now used for storage. A real nice "Ike" poster on rear wall inside. Built as a sock factory.

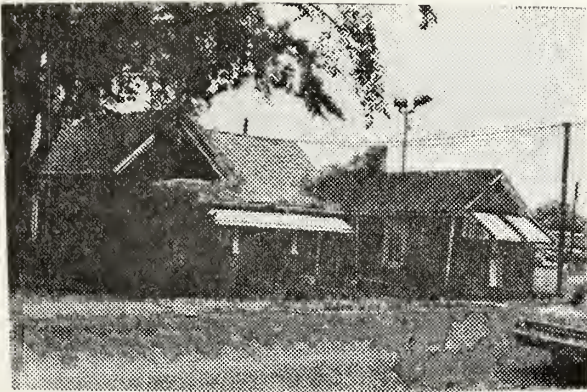
120. 106 South Alston. Pre-1913
One-story gabled mill house remodeled as bungalow, but retains original Queen Anne windows and L-shaped plan. Simple brick store added on north side of structure

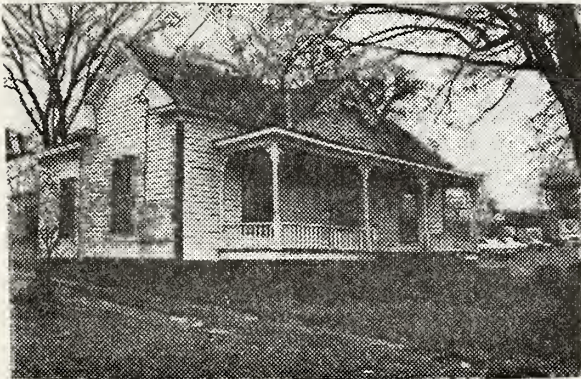
121. 105,108 South Alston. Pre-1913
Pair of houses representative of the dominant house type on this section of Alston Avenue before commercial development began. Typically those dwellings are 3 bay, "triple A" weatherboarded structures with 6/6 front windows and 4/4 side windows, and front hip roofed porches. Other common features include curvilinear sawnwork bargeboard, tulip motif porch brackets, and pedimented window surrounds.

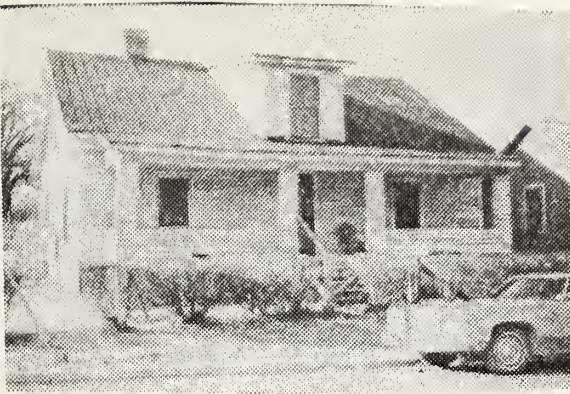
127. 115 North Blacknall Street. 1913-1937
Simple side gabled, one and a half story three bay house with weatherboard. Shed dormer with 2/2 window was probably added when front porch was altered by substitution of bungalow style weatherboarded railings and posts. 6/1 front windows and raised standing seam tin roof.

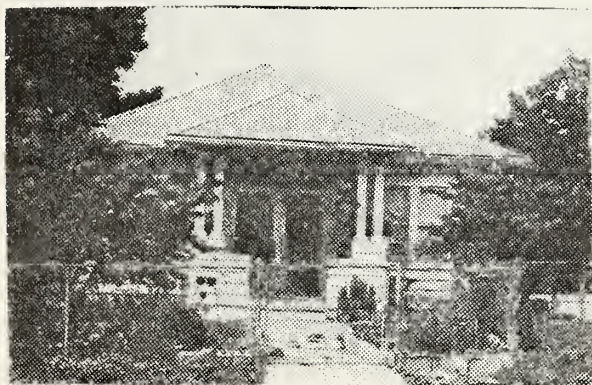
133. 109 South Holman Street. Pre-1913
One-story frame bungalow with hip roof and hip roofed one-bay porch supported by paired Doric posts on pedestals. Three bay facade composed of two sets of paired windows and central paired doors. House on site of an earlier home. House is in excellent condition and is used as a rectory for adjacent church of our Lord Jesus Christ of the Apostolic Faith.

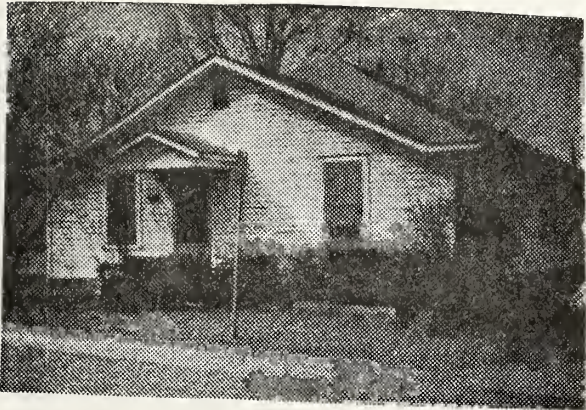
136. 115 North Holman Street. 1913-1937
 One-story house with hip roof, front cross gable, central chimney, German siding, 9/1 sash windows, and replacement front door. Apparently front porch was later enclosed and a modern stoop added.

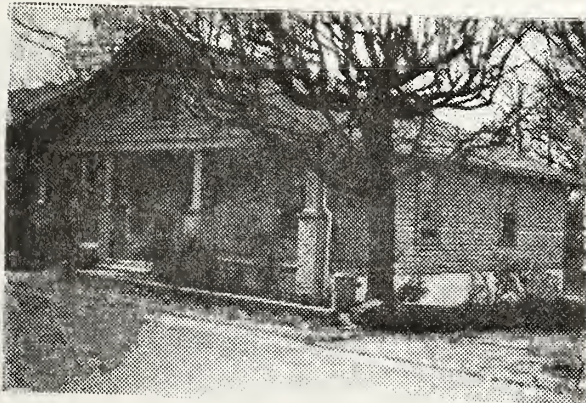
137. 117 North Holman Street. Pre-1913-1937
 One-story frame bungalow with front gable extended to form front porch, supported on Doric posts on brick piers. Two interior chimneys, assymetrical three bay front elevation. House remodeled from older mill house type.

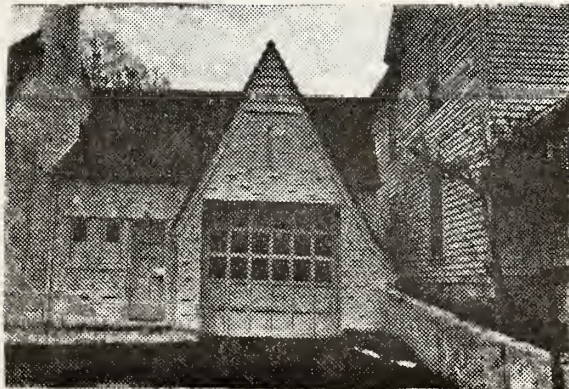
138. Mill Park Gas Station. 1200 East Main Street. 1929
 Whimsical early gas station addresses all streets from corner site. Three sided, painted, skinteled brick one-story building. Steeply gabled blue ceramic tile roof; two exterior end chimneys. Picturesque French chateau image, typical of Pure Oil stations of twenties and thirties. Three parts of building include two garage wings with tin ceilings and angled central office.

Of the many commercial buildings to be found, the Mill Park Gas station, at the south-east corner of East Main and South Alston, is of the greatest interest architecturally. Among the first generation of gas stations designed as advertisements, this whimsical Pure Oil station, built in 1929, is perfectly intact, and still retains its blue and white coloration.

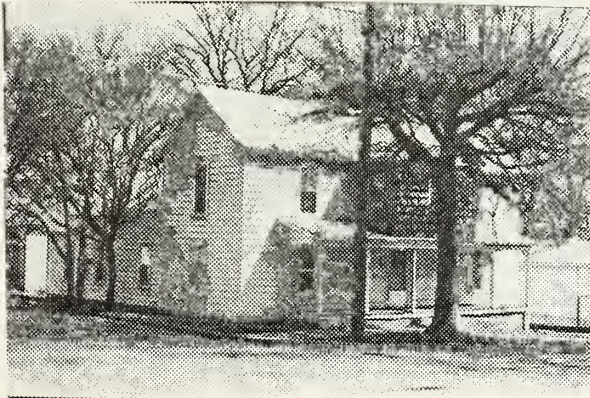
140. 1301 East Main Street. Pre-1913
Two-story frame "triple A" "I" house with many rear additions, 2/2 sash windows, three partially rebuilt chimneys (one exterior, two interior), three bay front porch with turned posts and a few original tulip motif brackets. The original center balcony has been enclosed. This house, formerly used by the Durham Mission, has one of the best preserved and most elegant interiors in the neighborhood, featuring Victorian mantels, newel post, and woodwork.

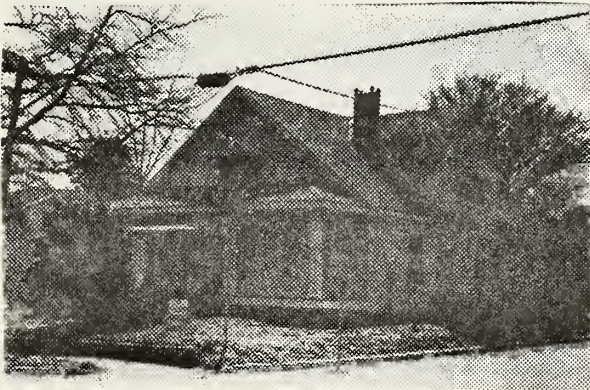
141. 1302 East Main Street. Pre-1913
One-and-a-half story frame house with gabled end facing street and large side gabled dormer. One interior chimney, 6/6 sash windows, three bay front porch with standard bungalow posts and German siding.

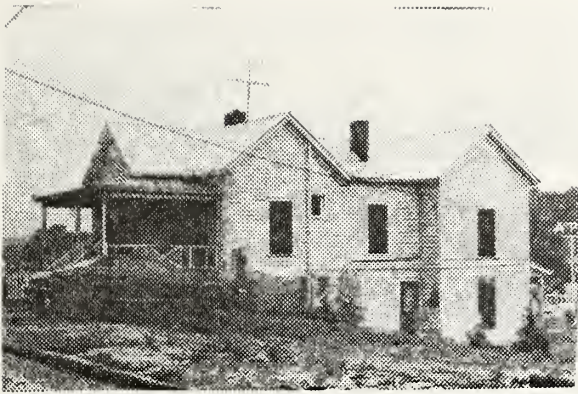
147. 107 Stokes Street. Pre-1913

Unusually large one-story gabled frame house situated on steeply graded lot, front hip roofed porch has two original engaged columns, and replacement posts. Two interior chimneys, 2/2 sash windows and standing seam metal roof with front cross-gable. Only home remaining of four identical homes formerly on Stokes, probably built by the Durham Hosiery Mill.

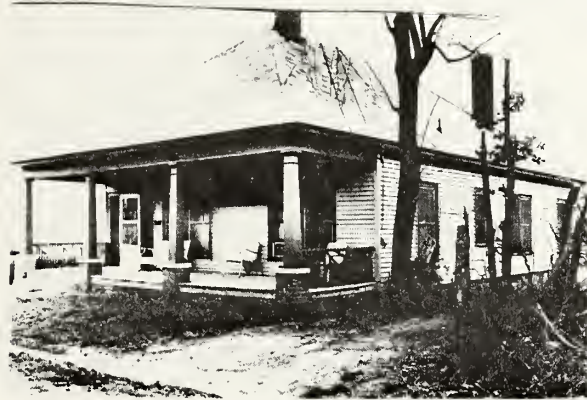
148. 113 Stokes. 1913-1937

One-story frame single family bungalow, set narrow end to street, with stylish engaged front porch. Probably not mill related.

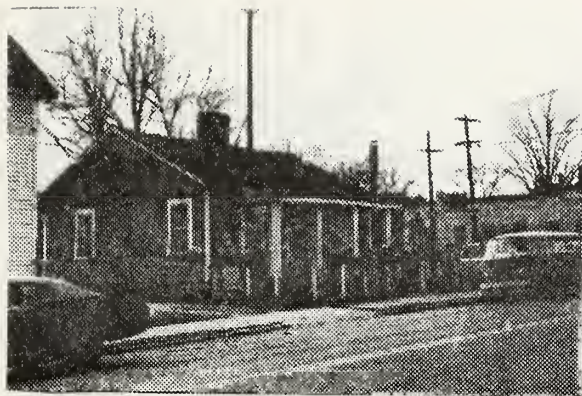
150. 209 South Holman Street and 1302 Angier Avenue. 1913-1937

Tiny one-story duplex mill house with central chimney, two front doors and two windows behind a full facade simple front porch. Unique as the smallest four room duplex in the area of Edgemont, it blends well with its larger neighbors. Not in generally good condition though not severely deteriorated. Apparently built by the Commonwealth Cotton Manufacturing Company.
